MERUS REFERENCE

WASTE WATER TREATMENT PLANT KOMUNALA KRANJ

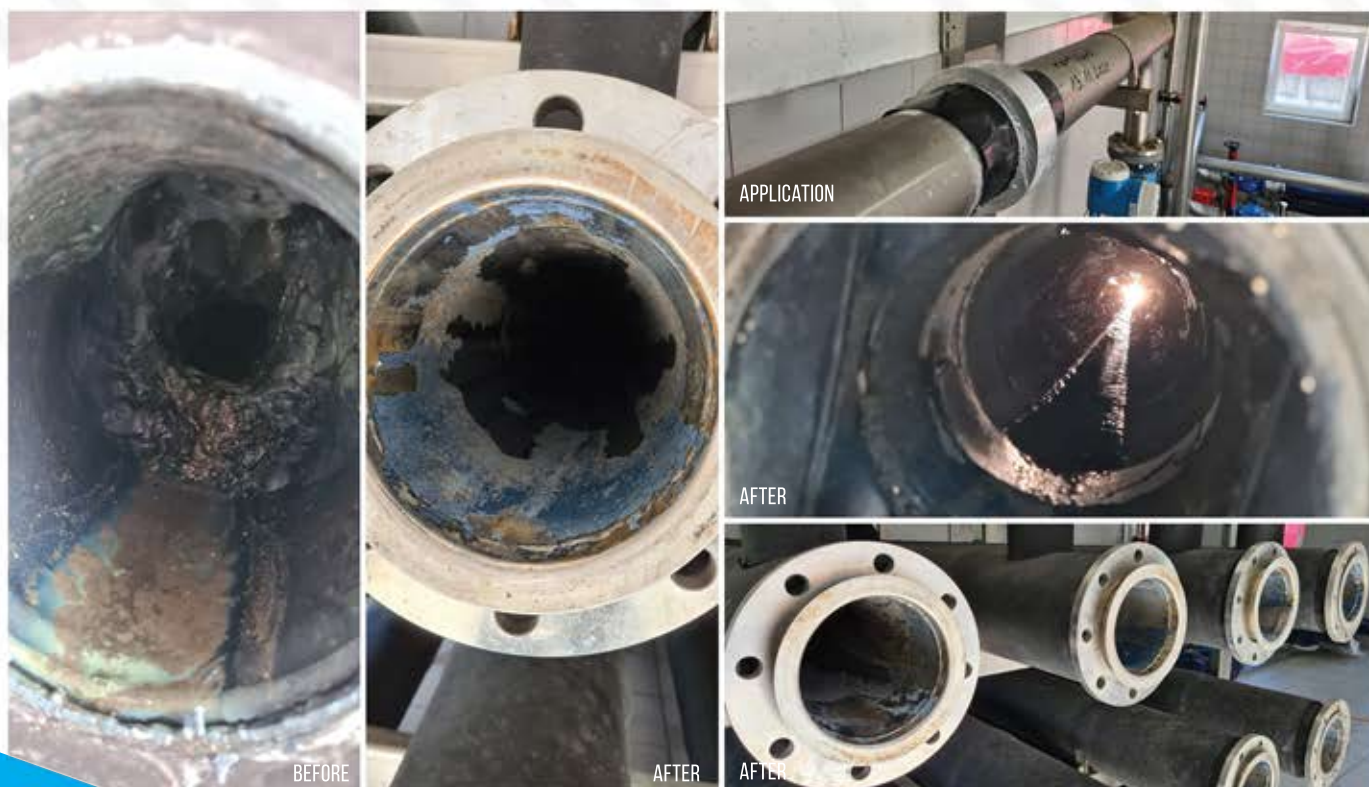
TEMPERATURE MONITORING ΔT :

THE TEMPERATURE WAS RECORDED BEFORE AND AFTER INSTALLATION OF THE 5" BIO HCl MERUS RING. AFTER 3 MONTHS, THE PIPES WERE INSPECTED BY X-RAY. DURING THE TEST PERIOD, THE PIPES WERE X-RAYED IN ORDER TO RECORD THEIR CONDITION.

A COMPARISON OF THE SYSTEM AND CONDITION OF THE PIPES, AS WELL AS IN THE HEAT EXCHANGER ITSELF, WAS ALSO DONE VISUALLY BEFORE AND AFTER THE RING. A DIFFERENCE BETWEEN BEFORE AND AFTER USING THE MERUS RING IS OBVIOUS. AFTER INSTALLATION OF MERUS RING, WE DO NOT NEED TO REPLACE THE PIPES ANYMORE, BUT ONLY EFFORTLESS PERIODICAL CLEANING OF PIPES AND HEAT EXCHANGER IS NEEDED. CONSEQUENTLY WE SIGNIFICANTLY SAVE ON MAINTENANCE COST AND HAVE SMOOTH PROCES.

TUBULAR HEAT EXCHANGER AND TUBES ARE MADE OF STAINLESS STEEL. DUE TO THE FLOW OF SLUDGE THROUGH PIPES AND ITS COMPOSITION, STRUVIT CRYSTALS OCCUR. THIS MEANS THAT INNER DIAMETER OF 5" PIPE IS REDUCED DUE TO FORMATION OF STRUVIT DEPOSITES. AS A RESULT, FLOW AND TEMPERATURE ARE ALSO REDUCED.
